*This Standard Timber Pest Detection Report (hereinafter called “the Report”) is issued subject to the Terms and Conditions of Inspection and Report set out in Clause A.1 of this document.*

Inspection Date: **11-02-2014**

NAME OF CLIENT: **Sam Sample**  
ADDRESS OF CLIENT:  
ADDRESS OF PROPERTY INSPECTED: **123 Sample Lane, Sampleton**  
DATE OF INSPECTION: **11-02-2014**  
NAME OF PRINCIPAL (where applicable):

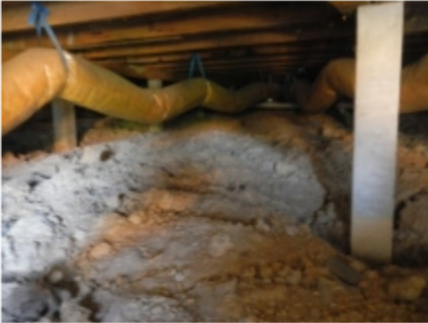
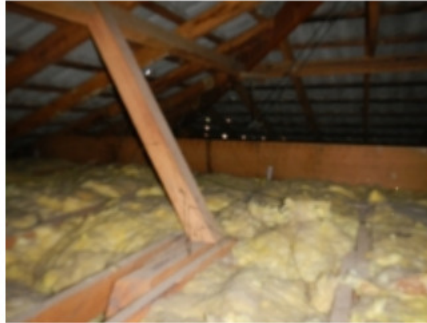
### Subfloor Space

Debris, Height restrictions, Pipe/duct work.

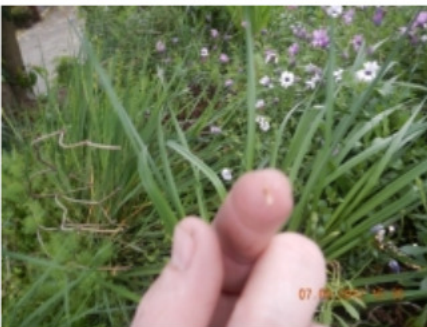
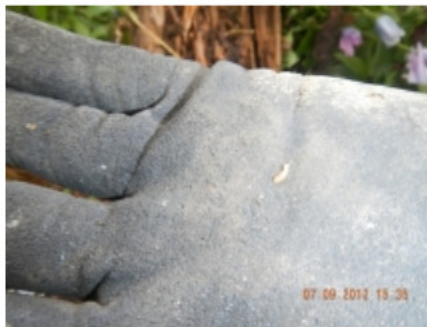
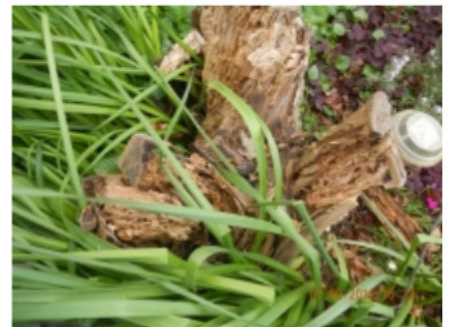
Were live termites found?

Yes

**Live termites found in tree stump:**

**Regular Inspections is recommended, Eradication and preventative as per AS 3660:**

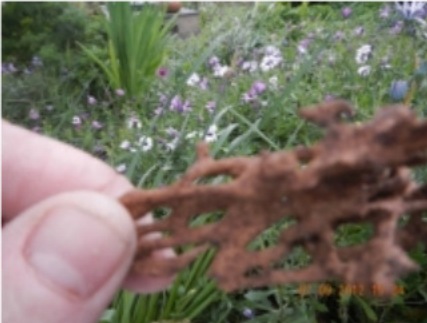
**Termite workings and/or damage was found in tree stump**
